Influence of Jacking Oil Supply Configuration on Shaft Vibration of a Super-Synchronous Motor

Tim Hattenbach, P.E.
Feroze Meher-Homji, P.E.
Bechtel Corporation Houston, Texas

CASE STUDY: 38TH TURBOMACHINERY SYMPOSIUM

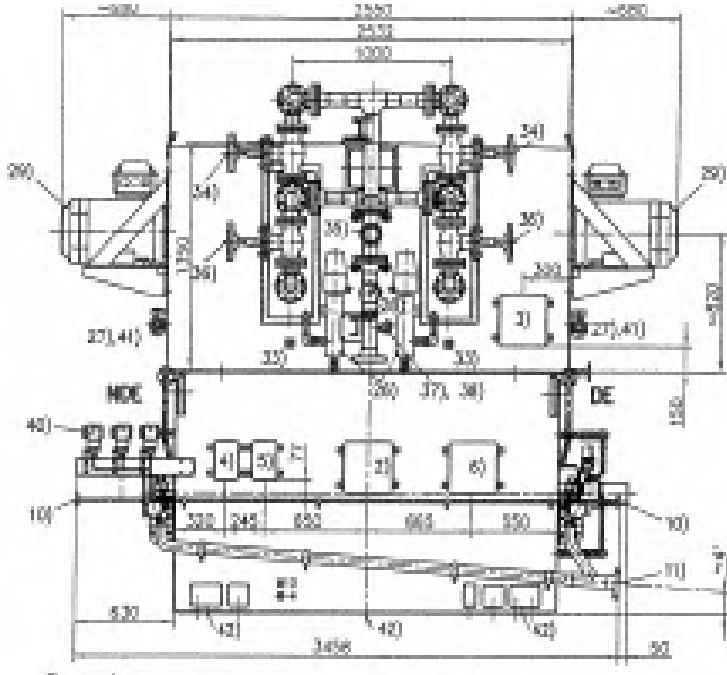
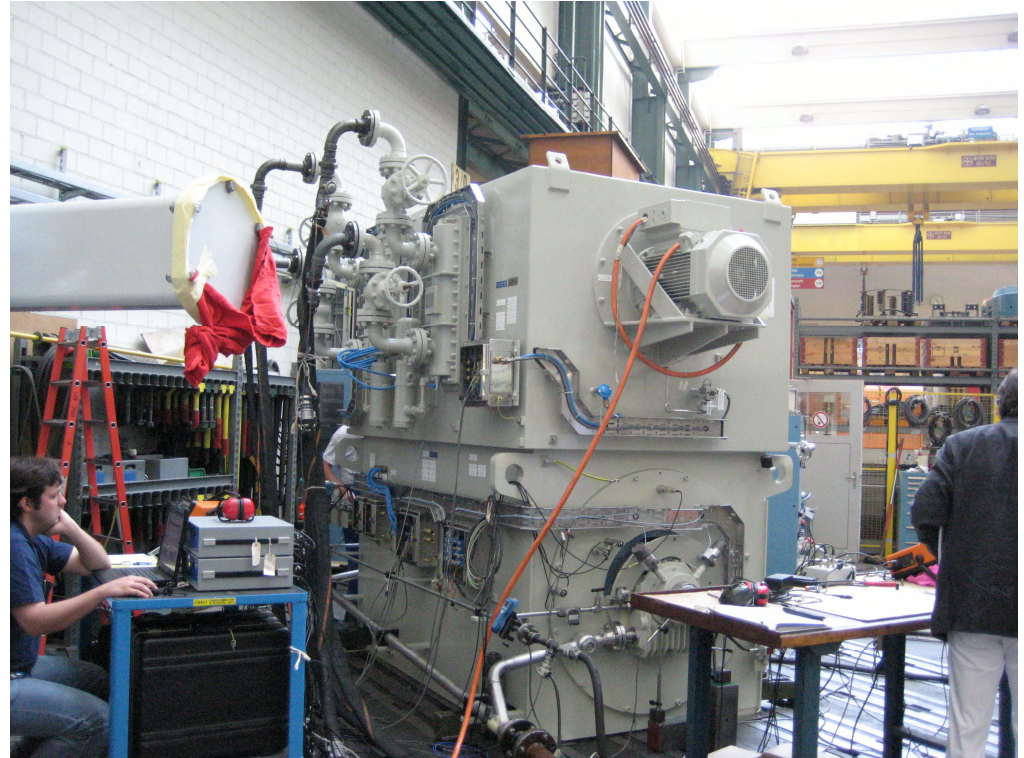
6.6 MW Electric Motor

Jacking oil (Nominal pressure 80 Bar) is supplied through hoses to motor bearings from a dedicated pump. The check valves are located outside the bearing housings

Used only during start up and shutdown

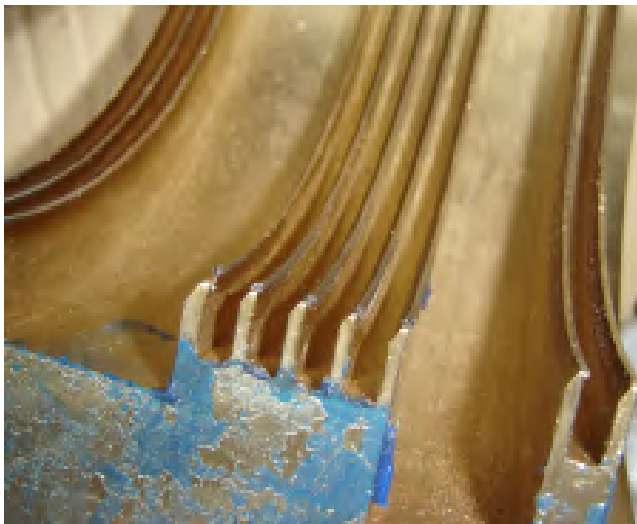
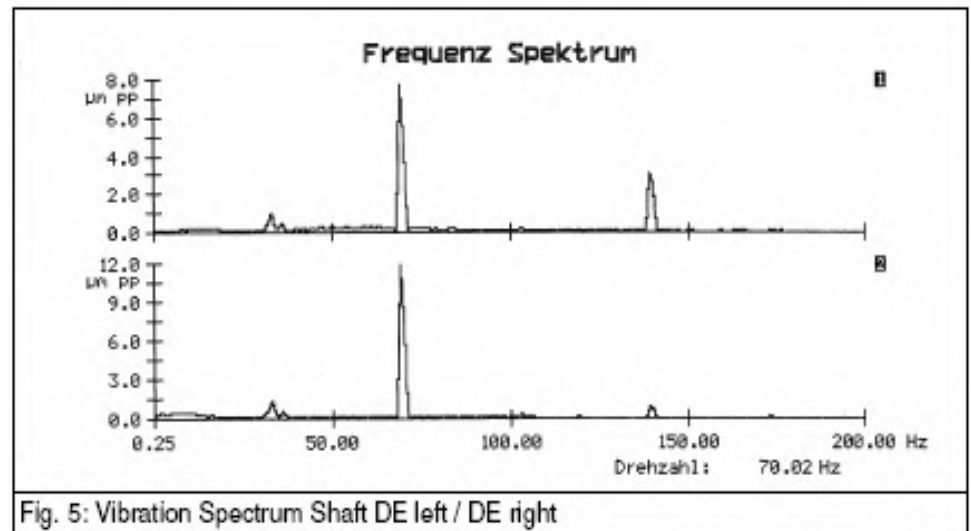
First development of SSV at 1st Critical

Motor tested at full speed using job VFD.

Max vibration 51 microns pk-pk -SSV noted at 1st Bending Critical and its second harmonic

High sub-synchronous vibration above 4800 RPM-Because of the contractors's insistence the motor was run at its rated speed 5100 RPM .The unfiltered vibration exceeded 50 Microns Pk-PK at the NDE Bearing-Clearly unacceptable

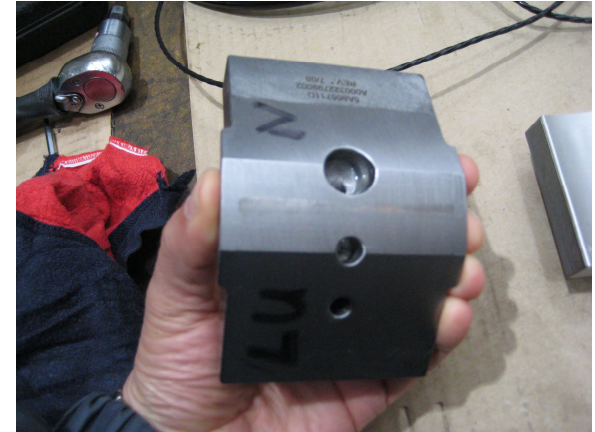
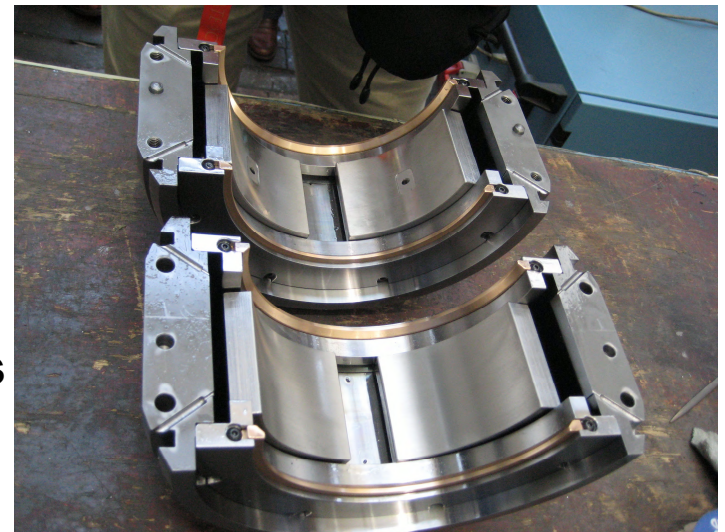
4 lobe Load between Pads Tilting pad bearings designed to replace existing bearings- design constrained by existing bearing housing.

A new lateral analysis with the proposed revised bearing design-4 pad tilt pad bearings- Showed significantly improved damping

The jacking oil was now injected through a single hole in each lower tilting pad, connected by a hose and an external check valve (Same as with the 4 lobe bearing design)

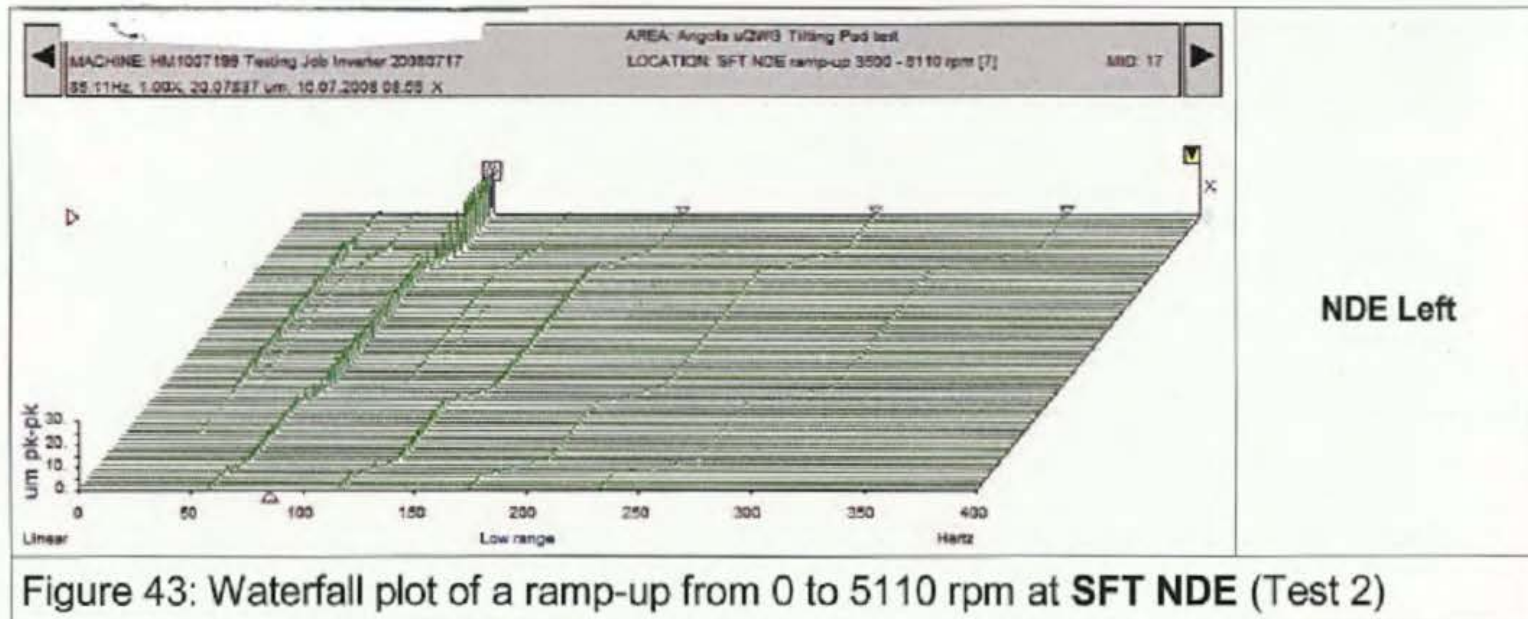
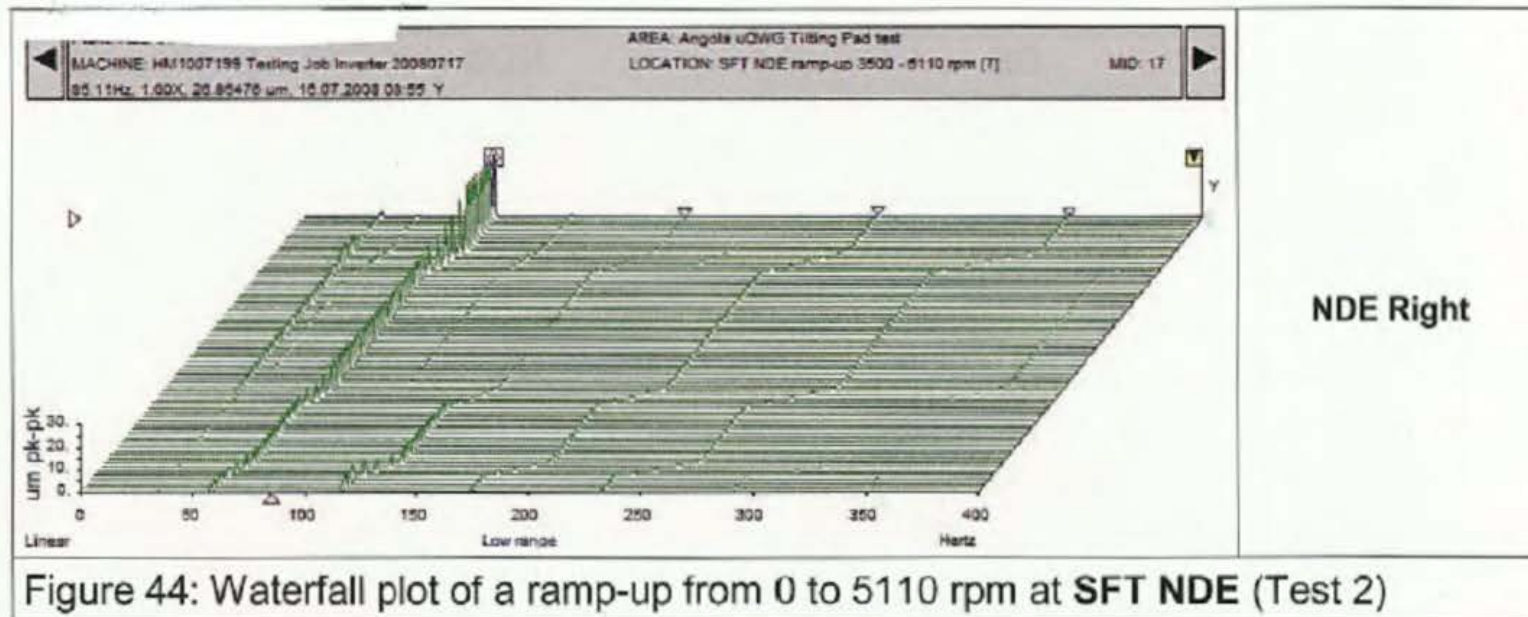
Non-drive end side (SFT NDE) at $T_{in}=42^{\circ}\text{C}$ and 18 l/min/bearing

Witness Test with TPJs-Vibn too high to reach rated speed
